PHOTOGRAPHIC SURVEY OF THE LDEF MISSION

NASA Special Publication 531

Robert L. O'Neal

Langley Research Center
Hampton, Virginia 23681-0001

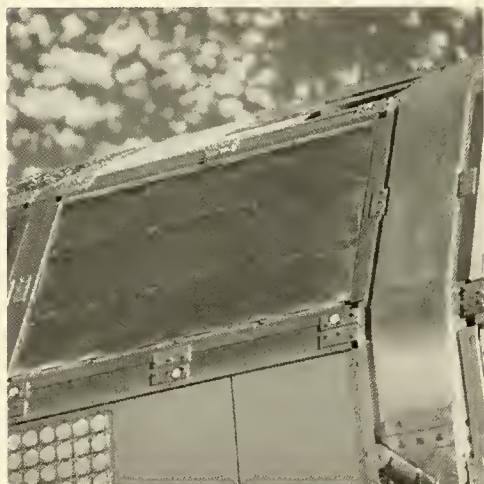
Figure 336 (In Flight). The thermal cover is without physical damage and is taut. The blue appearance of the thermal cover in this photograph is due to lighting conditions and not a change in the material optical properties. The oblong indentations in the thermal cover surface are areas where Velcro attachment pads are bonded to the back of the cover. The surface of the thermal cover appears to have small light blue circular discolorations of various sizes that appear to be impacts. The white irregular shapes in the photograph are light reflections from the edges of indentations in the cover surface. The scalloped edge along the left side of the thermal cover occurs between attachment pads. The ground strap is in place with no visible damage, but it also appears to be a deeper copper color than in the prelaunch photograph.

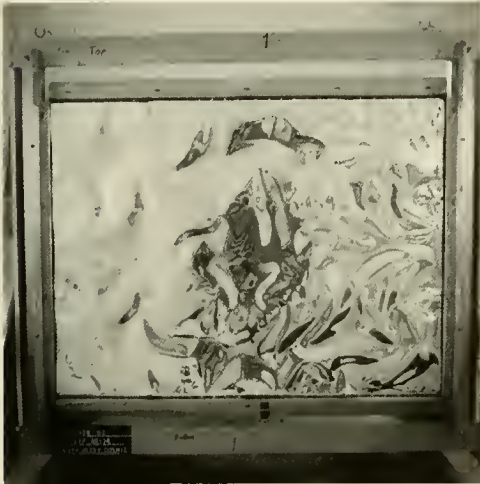
Figure 337
Photo No.: KSC-390C-1472.02
Dup. Neg.: L91-10248
LISAR No.: EL-1994-00207
Photo Credit: KSC
Photo Date: 2/26/90
Location: KSC SAEF II
Subject: Postflight Survey of Tray D7

Figure 337 (Postflight). The surface of the thermal cover appears specular with green and white discolorations from photographic lights and reflections of the surrounding area. The black or brown dots are impacts or penetrations. The cover is not as taut as in the in-flight photograph and locations of the Velcro attachment pads are not as prominent. The ground strap has no apparent physical damage, but it is a darker copper color than in the prelaunch photograph.

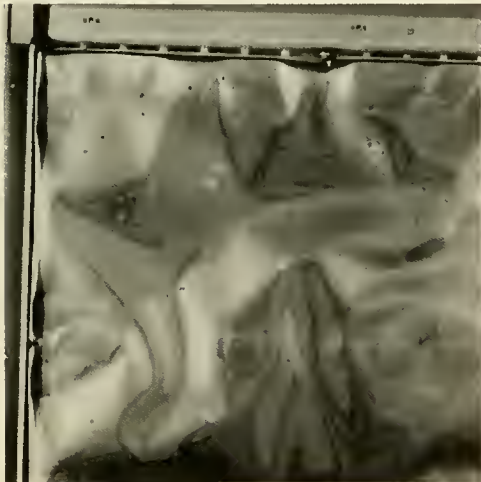
Figure 338
Photo No.: KSC-390C-1472.09
Dup. Neg. No.: L91-10255
LISAR No.: EL-1994-00194
Photo Credit: KSC
Photo Date: 2/26/90
Location: KSC SAEF II
Subject: Postflight Detail of Upper Left of Tray D7

Figure 338 (Postflight). This photograph is of the upper left one-sixth of the tray. The thermal cover appears specular with some small discolored impacts or penetrations. The reflective properties of the uneven surface of the cover result in various light and color patterns. The locations of the Velcro attachment pads are obvious.

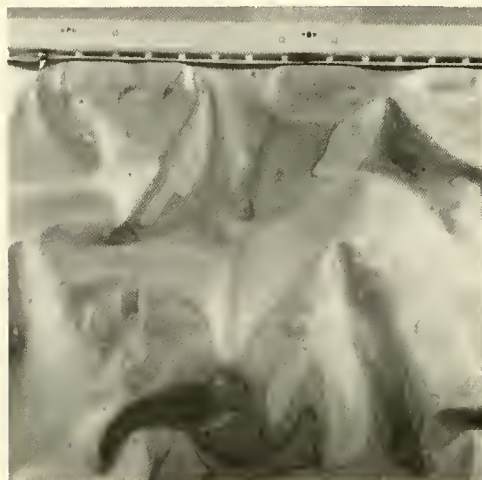
Figure 339 (Postflight). This photograph is of the upper center one-sixth of the tray. The thermal cover appears specular with some small discolored impacts or penetrations. The reflective properties of the uneven surface of the cover result in various light and color patterns. The locations of the Velcro attachment pads are obvious.

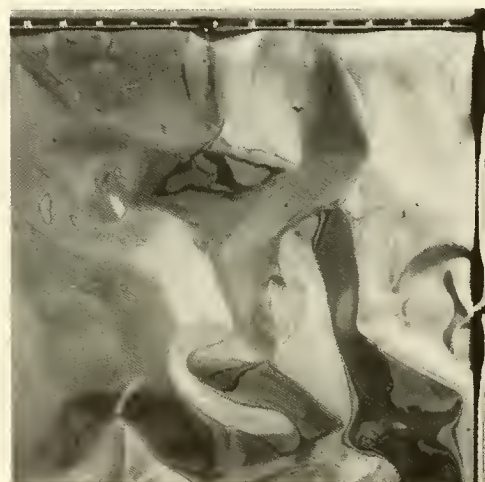
Figure 340 (Postflight). This photograph is of the upper right one-sixth of the tray. The thermal cover appears specular with some small discolored impacts or penetrations. The reflective properties of the uneven surface of the cover result in various light and color patterns. The locations of the Velcro attachment pads are obvious.

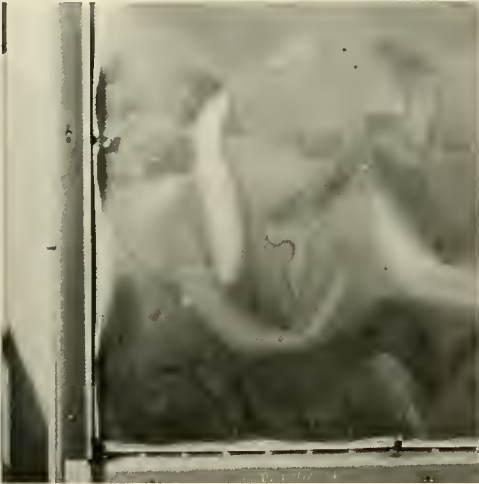
Figure 341 (Postflight). This photograph is of the lower left one-sixth of the tray. The thermal cover appears specular with some small discolored impacts or penetrations. The reflective properties of the uneven surface of the cover result in various light and color patterns. The locations of the Velcro attachment pads are obvious.

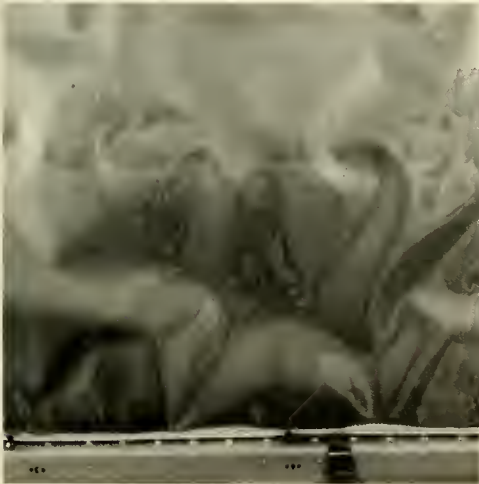
Figure 342 (Postflight). This photograph is of the lower center one-sixth of the tray. The thermal cover appears specular with some small discolored impacts or penetrations. The reflective properties of the uneven surface of the cover result in various light and color patterns. The locations of the Velcro attachment pads are obvious.

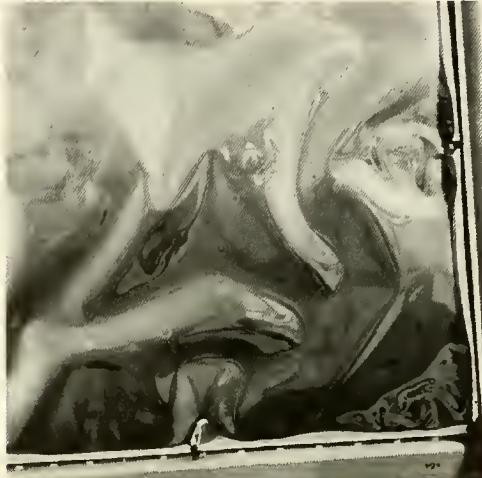
Figure 343 (Postflight). This photograph is of the lower right one-sixth of the tray. The thermal cover appears specular with some small discolored impacts or penetrations. The reflective properties of the uneven surface of the cover result in various light and color patterns. The locations of the Velcro attachment pads are obvious.

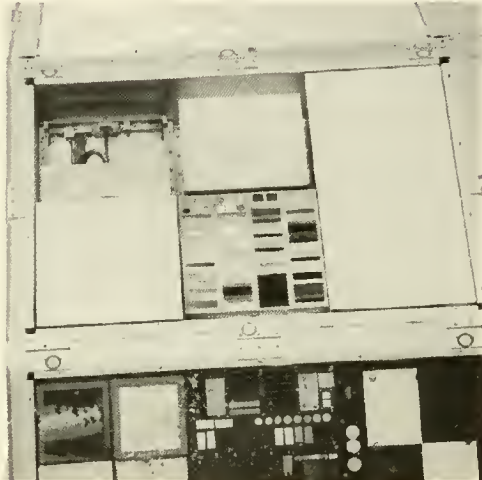
Figure 345 (In Flight). The experiment hardware appears intact. The EPDS cover located in the right one-third of the tray has no apparent change in color, but the SCU cover located in the upper center one-sixth of the tray has a brownish tint with a darker tan strip along the lower line of screws. Colors of the composite material samples are bright and clear. Some material samples appear to be blue in this photograph, but they are not in prelaunch or post-flight photographs.

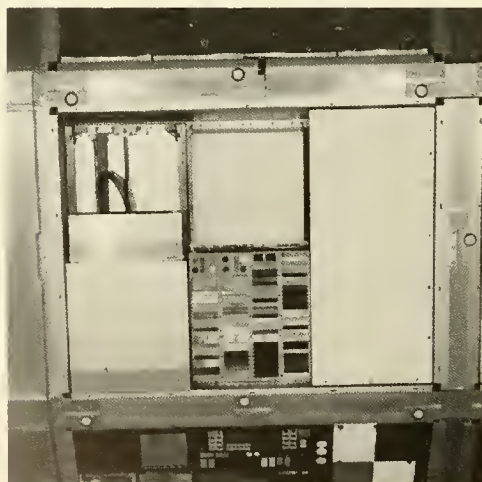
Figure 346 (Postflight). There seems to be no change from the in-flight appearance. All test specimens and hardware are intact. The EPDS cover, which was painted white, shows no apparent change in color, but the white paint on the SCU cover has a slight brownish tint. Some composite material samples are dull, some are discolored, and some are a different color from the preflight photograph. The bright square discolorations on the upper corners of the thermal cover are pads of tape that were used to cover sharp corners that were exposed. The pads were not in place in the prelaunch photograph.

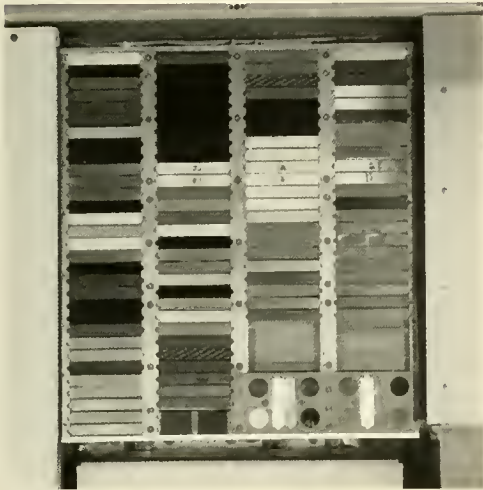
Figure 347 (Postflight). This photograph is of the lower center one-sixth of the tray. Many of the test samples have changed color and have degraded finishes. The test specimen mounting hardware has numerous brown discolorations.

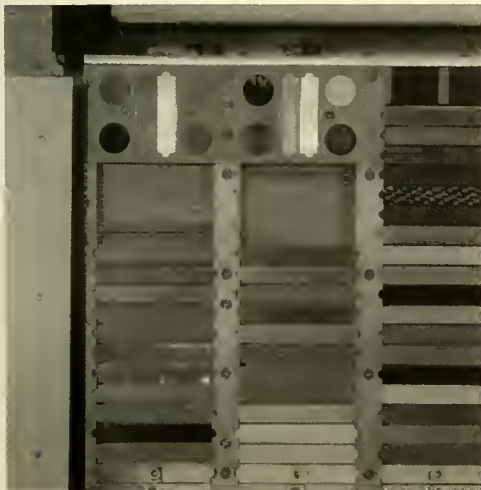
Figure 348 (Postflight). This close-up photograph is of the upper left of the lower center one-sixth of the tray. Many of the test samples have changed color and have degraded finishes. The test specimen mounting hardware has numerous brown discolorations.

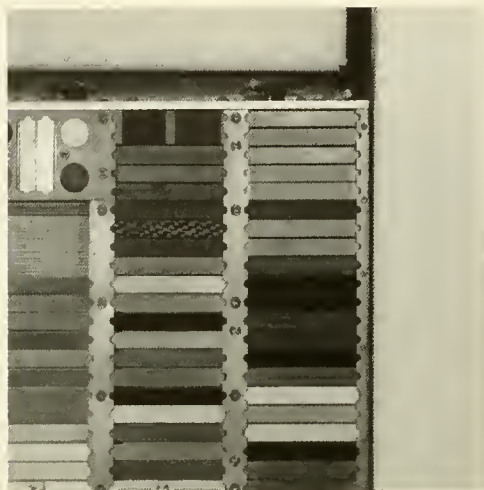
Figure 349 (Postflight). This close-up photograph is of the upper right of the lower center one-sixth of the tray. Many test samples have changed color and have degraded finishes. The test specimen mounting hardware has numerous brown discolorations.

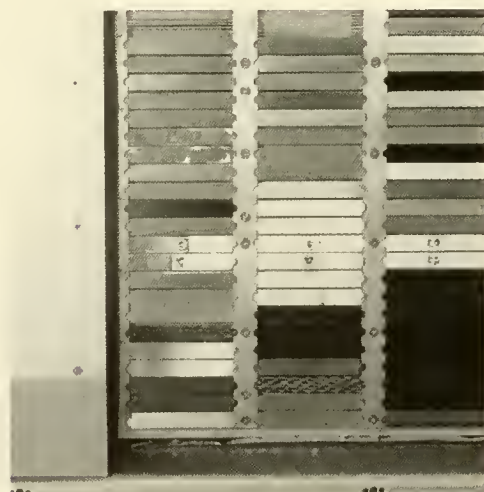
Figure 350 (Postflight). This close-up photograph is of the lower left of the lower center one-sixth of the tray. Many test samples have changed color and have degraded finishes. The test specimen mounting hardware has numerous brown discolorations.

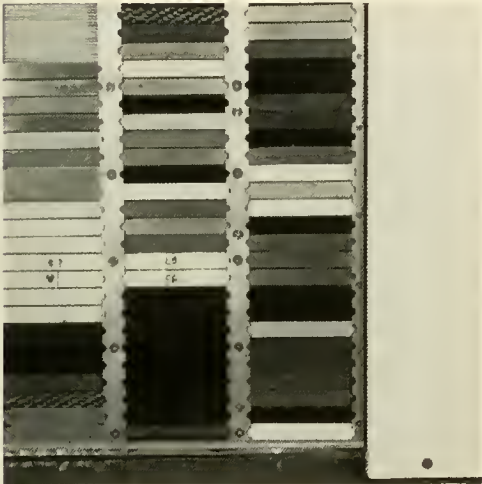
Figure 351 (Postflight). This close-up photograph is of the lower right of the lower center one-sixth of the tray. Many samples have changed color and have degraded finishes. The test specimen mounting hardware has numerous brown discolorations.

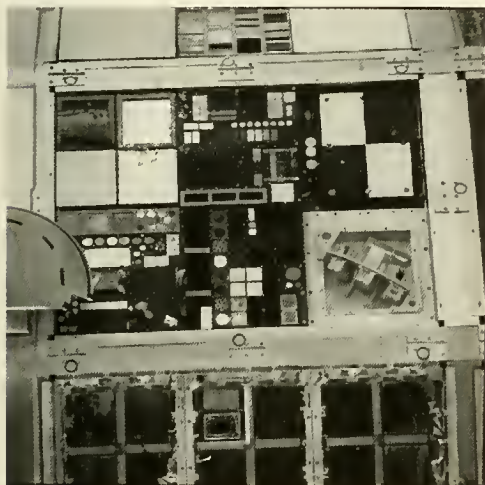
Figure 353 (In Flight). The experiments located in the upper left and upper center sections are heavily coated with debris particles from other degraded experiments. Experiments in three of the five sections appear to have survived the mission with only minor physical damage. Experiments in the other two sections have sustained damage to thin metallized and coated polymer samples.

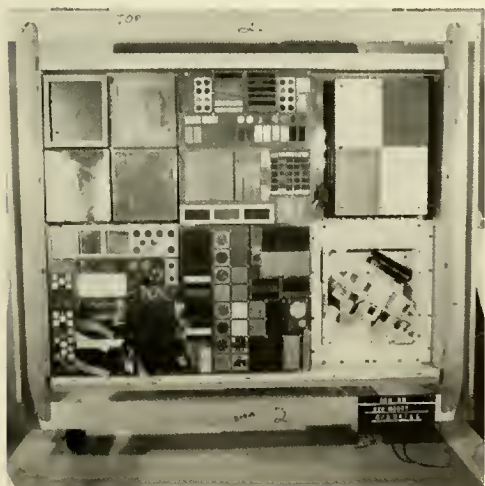
Figure 354 (Postflight). Experiments in three of the five sections appear to have survived the mission with minor physical damage. The experiments located in the upper left and upper center sections do not have the loose debris particles from the degradation of other experiments that were visible in the in-flight photograph. Experiments in the other two sections have sustained damage to thin metallized and coated polymer samples.

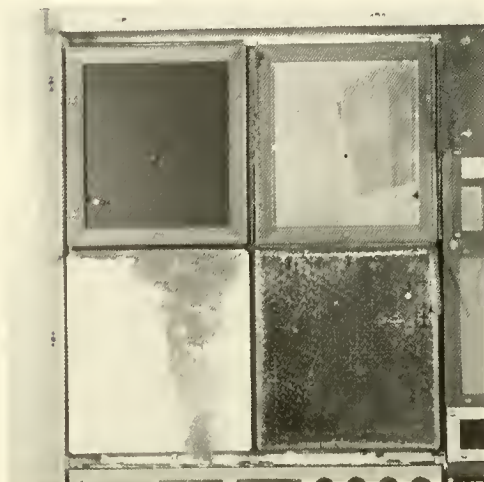
Figure 355 (Postflight). This photograph is of the upper left one-sixth of the tray. The thin film on the lower left corner is damaged. A shadow is visible on the upper right quadrant. A number of small impacts are visible.

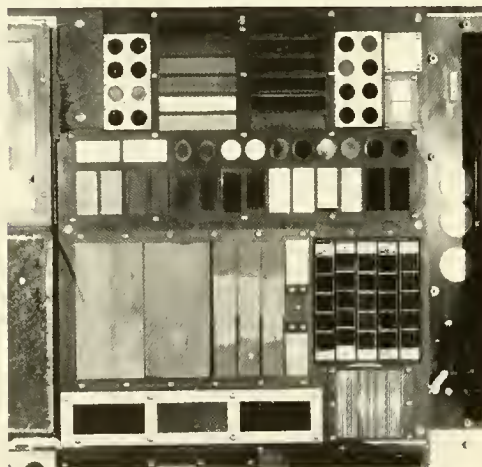
Figure 356 (Postflight). This photograph is of the upper center one-sixth of the tray. The test samples appear intact, but many are discolored.

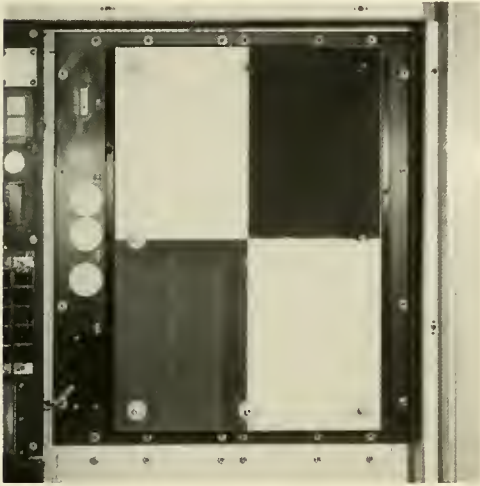
Figure 357 (Postflight). This photograph is of the upper right one-sixth of the tray. The test samples appear intact, but there seems to be some discoloration near the upper left corner of the baseplate.

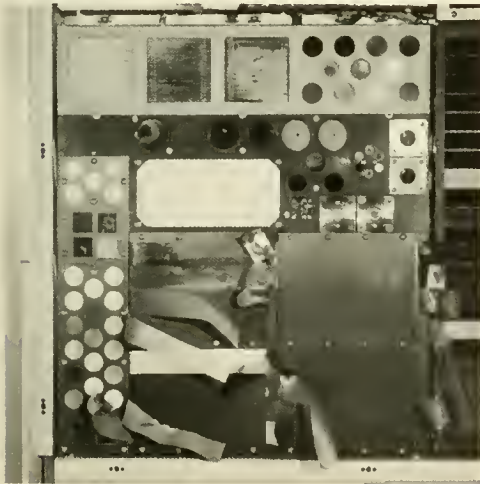
Figure 358 (Postflight). This photograph is of the lower left one-sixth of the tray. Many of the thin-film test specimens have broken and are attached by one end. Other test specimens appear intact, but some are discolored.

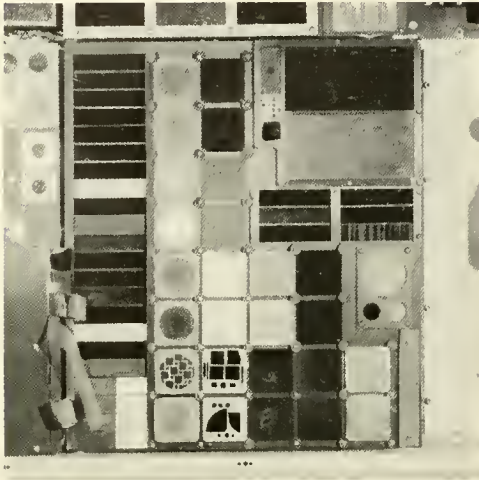
Figure 359 (Postflight). This photograph is of the lower center one-sixth of the tray. Loose ends of thin-film test samples are visible at the lower left corner. Other test specimens appear intact, but have some discoloration.

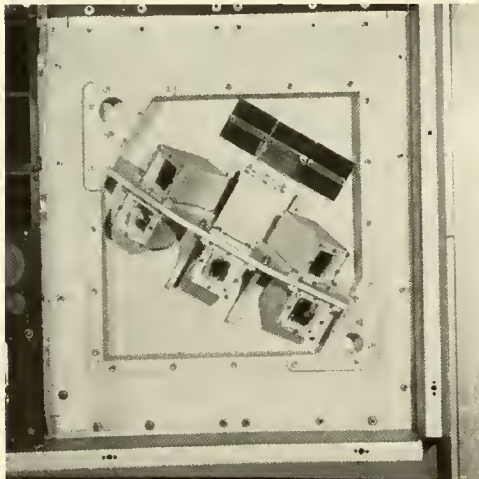
Figure 360 (Postflight). This photograph is of the lower right one-sixth of the tray. This experiment appears intact with some brown discoloration.

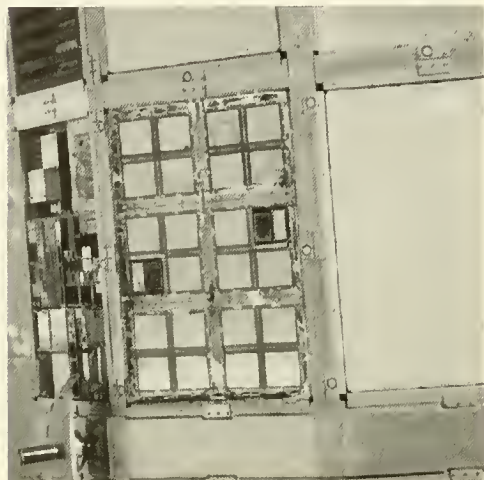
Figure 362 (In Flight). The experiment is severely degraded. The most noticeable change is that the VDA-Kapton strips used to cover spaces between the modules have degraded substantially and only fragments of the layer of vapor-deposited aluminum remain attached along the edges. Other areas also show major degradation.

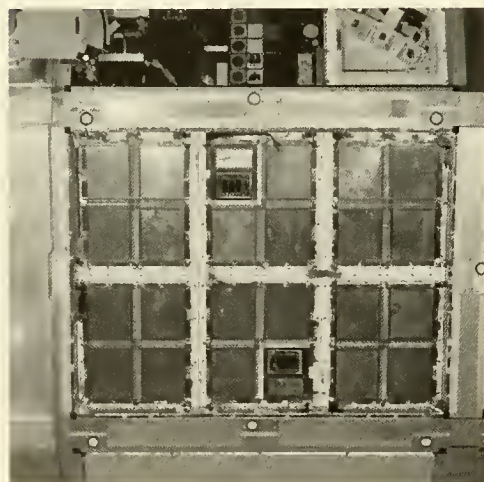
Figure 363 (Postflight). The experiment is severely degraded by impingement of atomic oxygen during exposure to the space environment. Most of the polyimide material making up the dielectric samples was completely eroded, thus leaving only the 2000 A to 3000 A layer of VDA bonded to the module.

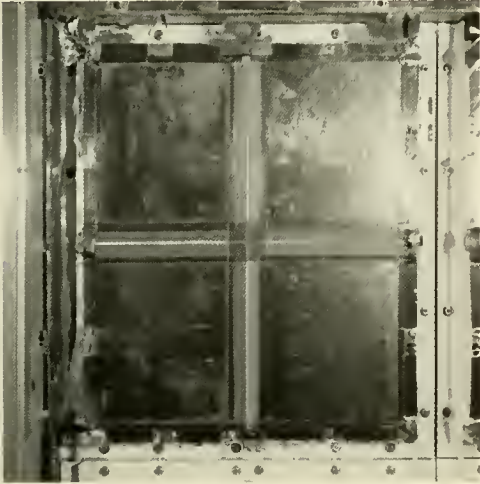
Figure 364 (Postflight). This photograph is of the upper left one-sixth of the tray. The polyimide material making up the dielectric samples was completely eroded, thus leaving only the 2000 A to 3000 A layer of VDA bonded to the module. The edges of the dielectric surface that survived were covered by Kapton tape with a silicone adhesive. The Kapton backing eroded, thus leaving the silicone adhesive that protected the Kapton surface beneath. The VDA-Kapton strips used to cover spaces between the modules were degraded substantially and only fragments of the extremely fragile VDA layer remain.

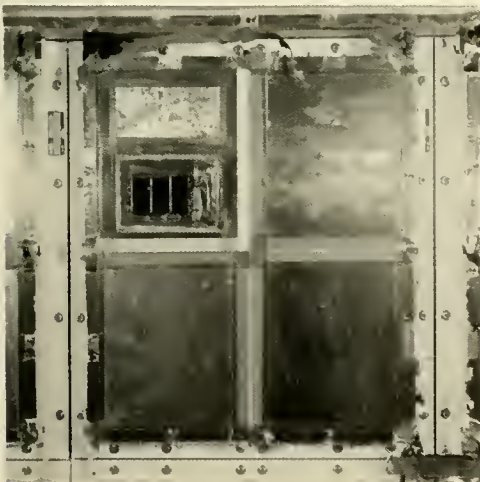
Figure 365 (Postflight). This photograph is of the upper center one-sixth of the tray. The polyimide material making up the dielectric samples was completely eroded, thus leaving only the 2000 A to 3000 A layer of VDA bonded to the module. The edges of the dielectric surface that survived were covered by Kapton tape with a silicone adhesive. The Kapton backing eroded, thus leaving the silicone adhesive that protected the Kapton surface beneath. The VDA-Kapton strips used to cover spaces between the modules were degraded substantially and only fragments of the extremely fragile VDA layer remain.

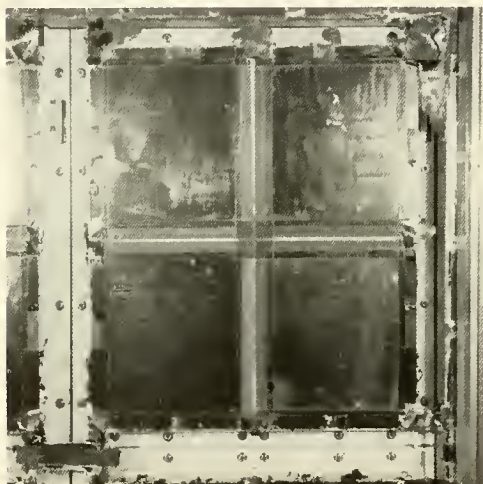
Figure 366 (Postflight). This photograph is of the upper right one-sixth of the tray. The polyimide material making up the dielectric samples was completely eroded, thus leaving only the 2000 A to 3000 A layer of VDA bonded to the module. The edges of the dielectric surface that survived were covered by Kapton tape with a silicone adhesive. The Kapton backing eroded, thus leaving the silicone adhesive that protected the Kapton surface beneath. The VDA-Kapton strips used to cover spaces between the modules were degraded substantially and only fragments of the extremely fragile VDA layer remain.

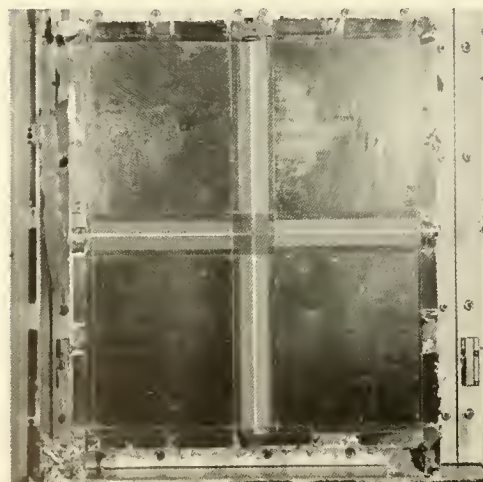
Figure 367
Photo No.: KSC-390C-1770.08
Dup. Neg. No.: L91-9110
LISAR No.: EL-1994-00225
Photo Credit: KSC
Photo Date: 3/9/90
Location: KSC SAEF II
Subject: Postflight Detail of Lower Left of Tray D10

Figure 367 (Postflight). This photograph is of the lower left one-sixth of the tray. The polyimide material making up the dielectric samples was completely eroded, thus leaving only the 2000 A to 3000 A layer of VDA bonded to the module. The edges of the dielectric surface that survived were covered by Kapton tape with a silicone adhesive. The Kapton backing eroded, thus leaving the silicone adhesive that protected the Kapton surface beneath. The VDA-Kapton strips used to cover spaces between the modules were degraded substantially and only fragments of the extremely fragile VDA layer remain.

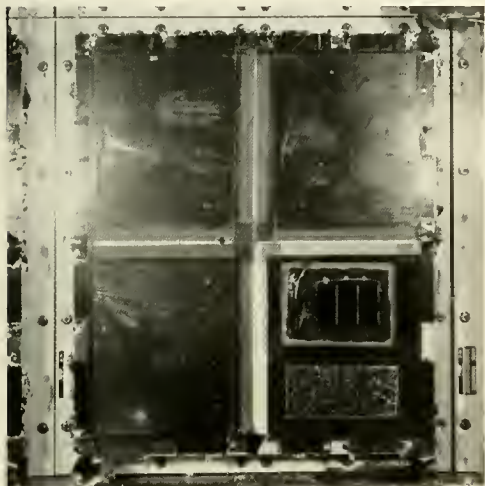
Figure 368
Photo No.: KSC-390C-1770.09
Dup. Neg. No.: L91-9111
LISAR No.: EL-1994-00226
Photo Credit: KSC
Photo Date: 3/9/90
Location: KSC SAEF II
Subject: Postflight Detail of Lower Center of
Tray D10

Figure 368 (Postflight). This photograph is of the lower center one-sixth of the tray. The polyimide material making up the dielectric samples was completely eroded, thus leaving only the 2000 A to 3000 A layer of VDA bonded to the module. The edges of the dielectric surface that survived were covered by Kapton tape with a silicone adhesive. The Kapton backing eroded, thus leaving the silicone adhesive that protected the Kapton surface beneath. The VDA-Kapton strips used to cover spaces between the modules were degraded substantially and only fragments of the extremely fragile VDA layer remain.

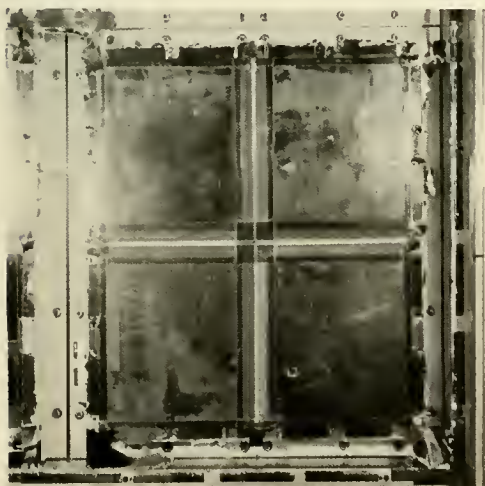
Figure 369
Photo No.: KSC-390C-1770.10
Dup. Neg. No.: L91-9112
LISAR No.: EL-1994-00227
Photo Credit: KSC
Photo Date: 3/9/90
Location: KSC SAEF II
Subject: Postflight Detail of Lower Right of
Tray D10

Figure 369 (Postflight). This photograph is of the lower right one-sixth of the tray. The polyimide material making up the dielectric samples was completely eroded, thus leaving only the 2000 A to 3000 A layer of VDA bonded to the module. The edges of the dielectric surface that survived were covered by Kapton tape with a silicone adhesive. The Kapton backing eroded, thus leaving the silicone adhesive that protected the Kapton surface beneath. The VDA-Kapton strips used to cover spaces between the modules were degraded substantially and only fragments of the extremely fragile VDA layer remain.

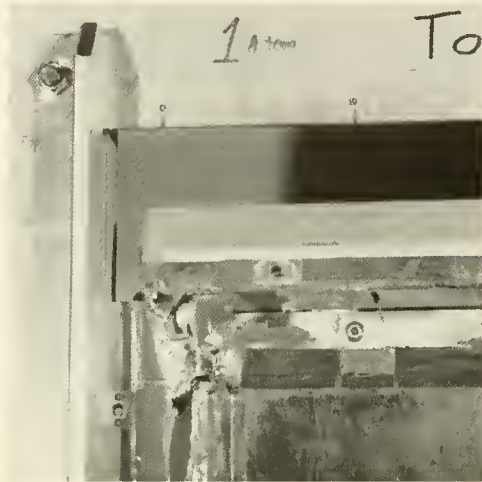
Figure 370 (Postflight). This photograph is of the upper left corner of the tray. The VDA-Kapton strips used to cover spaces between the modules have degraded substantially and only fragments of the extremely fragile VDA layer remain.

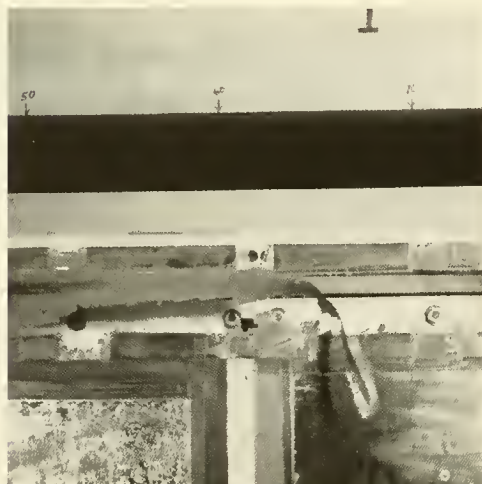
Figure 371 (Postflight). This photograph is of the upper center edge of the tray. The VDA-Kapton strips used to cover spaces between the modules have degraded substantially and only fragments of the extremely fragile VDA layer remain.

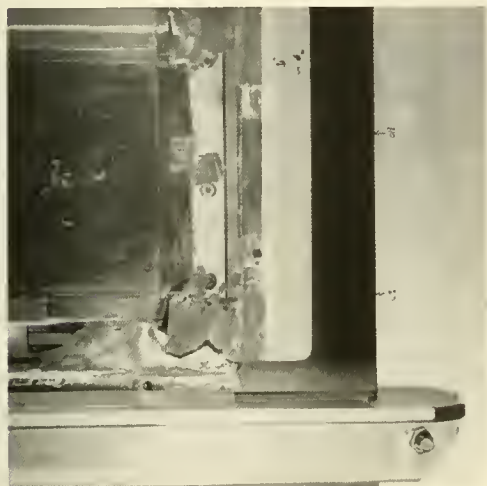
Figure 372 (Postflight). This photograph is of the lower right corner of the tray. The VDA-Kapton strips used to cover spaces between the modules have degraded substantially and only fragments of the extremely fragile VDA layer remain.

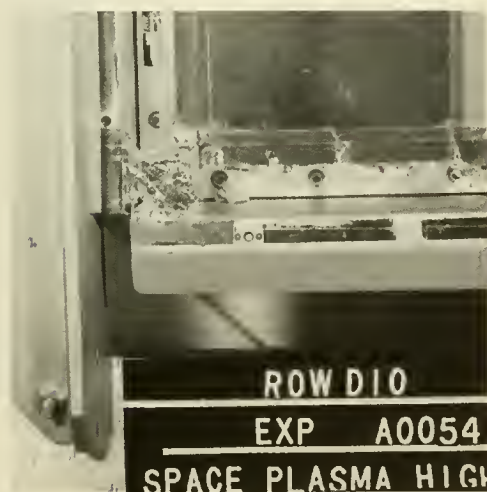
Figure 373 (Postflight). This photograph is of the lower left corner of the tray. The VDA-Kapton strips used to cover spaces between the modules have degraded substantially and only fragments of the extremely fragile VDA layer remain.

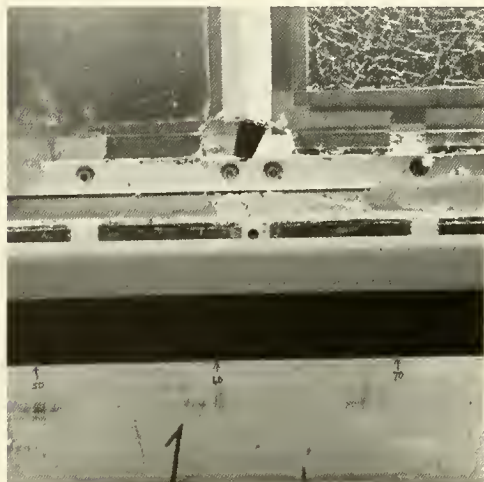
Figure 374 (Postflight). This photograph is of the lower center edge of the tray. The VDA-Kapton strips used to cover spaces between the modules have degraded substantially and only fragments of the extremely fragile VDA layer remain.

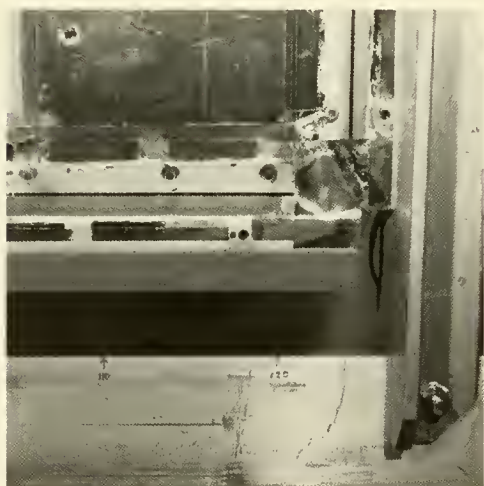
Figure 375 (Postflight). This photograph is of the lower right corner of the tray. The VDA-Kapton strips used to cover spaces between the modules have degraded substantially and only fragments of the extremely fragile VDA layer remain.

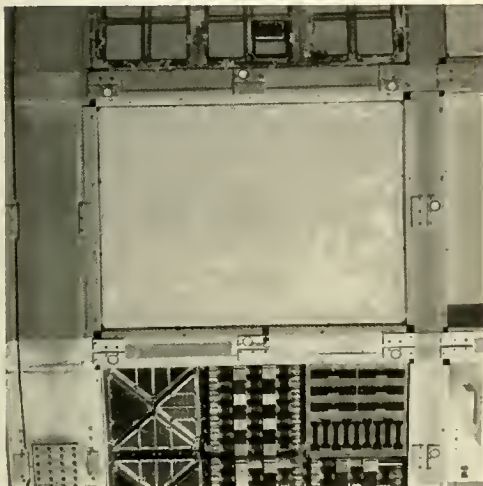
Figure 376 (In Flight). The thermal cover surface has changed from specular to opaque with numerous black dots and dimples of various sizes that indicate space debris impacts or penetrations. There is an area of reflected light in the lower right area. The cover is taut and the locations of Velcro attachment pads are prominent. The ground strap appears to have no visible damage, but it appears to be a deeper copper color.

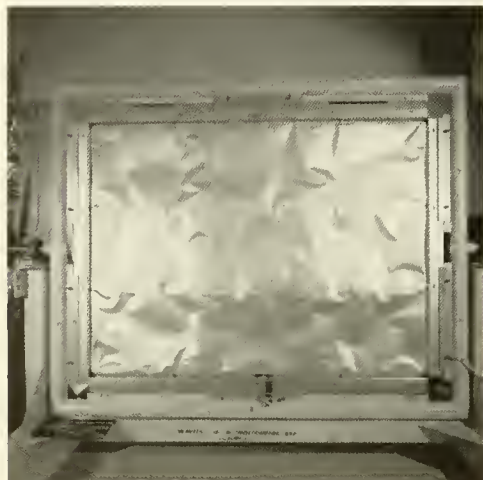
Figure 377
Photo No.: KSC-390C-1768.06
Dup. Neg. No.: L91-9382
LISAR No.: EL-1994-00277
Photo Credit: KSC
Photo Date: 3/9/90
Location: KSC SAEF II
Subject: Postflight Survey of Tray D11

Figure 377 (Postflight). The thermal cover surface has changed from specular to opaque. Reflected light obscures some surface details. There are a number of small dark spots, which indicate impacts or penetrations. The cover is not as taut as in the in-flight photograph and locations of Velcro attachment pads are not as prominent. The ground strap appears to have no visible damage, but it appears to be a deeper copper color.

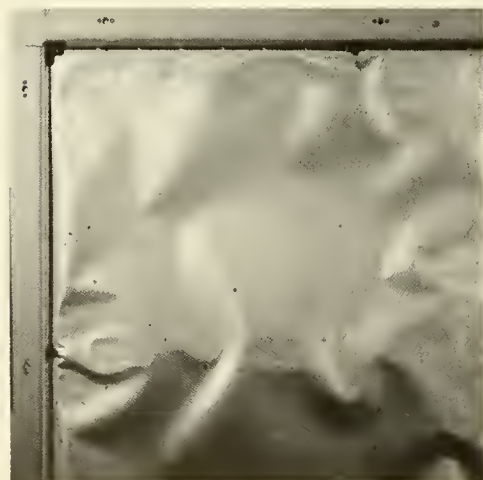
Figure 378
Photo No.: KSC-390C-1768.07
Dup. Neg. No.: L91-9383
LISAR No.: EL-1994-00257
Photo Credit: KSC
Photo Date: 3/9/90
Location: KSC SAEF II
Subject: Postflight Detail of Upper Left of Tray D11

Figure 378 (Postflight). This photograph is of the upper left one-sixth of the tray. The thermal cover appears opaque, rather than specular as it was in preflight photographs. There are numerous discolored impacts or penetrations visible. The Velcro thermal cover attachment pads are evident.

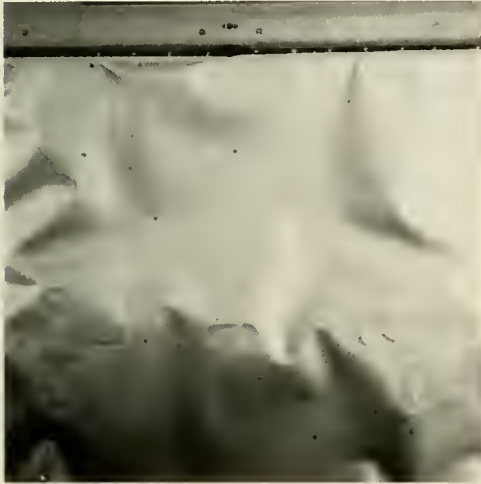
Figure 379
Photo No.: KSC-390C-1768.08
Dup. Neg. No.: L91-9384
LISAR No.: EL-1994-00258
Photo Credit: KSC
Photo Date: 3/9/90
Location: KSC SAEF II
Subject: Postflight Detail of Upper Center of
Tray D11

Figure 379 (Postflight). This photograph is of the upper center one-sixth of the tray. The thermal cover appears opaque, rather than specular as it was in preflight photographs. There are numerous discolored impacts or penetrations visible. The Velcro thermal cover attachment pads are evident.

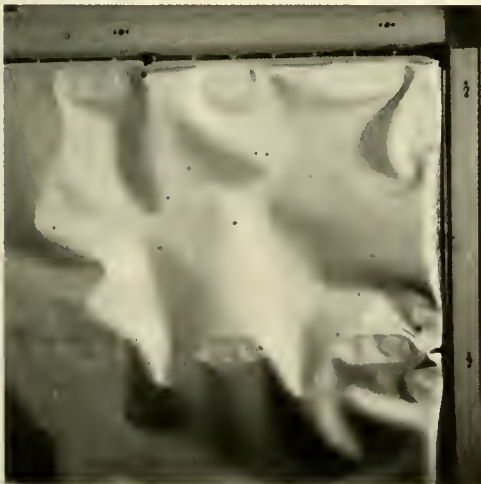
Figure 380
Photo No.: KSC-390C-1768.09
Dup. Neg. No.: L91-9385
LISAR No.: EL-1994-00242
Photo Credit: KSC
Photo Date: 3/9/90
Location: KSC SAEF II
Subject: Postflight Detail of Upper Right of
Tray D11

Figure 380 (Postflight). This photograph is of the upper right one-sixth of the tray. The thermal cover appears opaque, rather than specular as it was in preflight photographs. There are numerous discolored impacts or penetrations visible. The Velcro thermal cover attachment pads are evident.

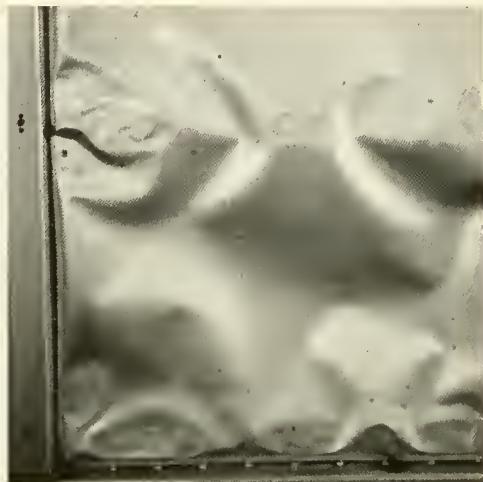
Figure 381 (Postflight). This photograph is of the lower left one-sixth of the tray. The thermal cover appears opaque, rather than specular as it was in preflight photographs. There are numerous discolored impacts or penetrations visible. The Velcro thermal cover attachment pads are evident.

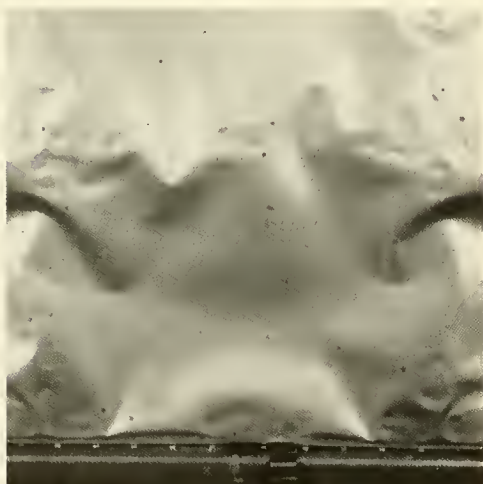
Figure 382 (Postflight). This photograph is of the lower center one-sixth of the tray. The thermal cover appears opaque, rather than specular as it was in preflight photographs. There are numerous discolored impacts or penetrations visible. The Velcro thermal cover attachment pads are evident.

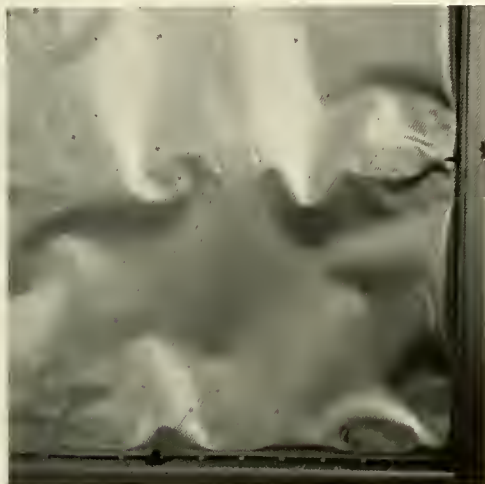
Figure 383
Photo No.: KSC-390C-1768.12
Dup. Neg. No.: L91-9388
LISAR No.: EL-1994-00221
Photo Credit: KSC
Photo Date: 3/9/90
Location: KSC SAEF II
Subject: Postflight Detail of Lower Right of
Tray D11

Figure 383 (Postflight). This photograph is of the lower right one-sixth of the tray. The thermal cover appears opaque, rather than specular as it was in preflight photographs. There are numerous discolored impacts or penetrations visible. The Velcro thermal cover attachment pads are evident.

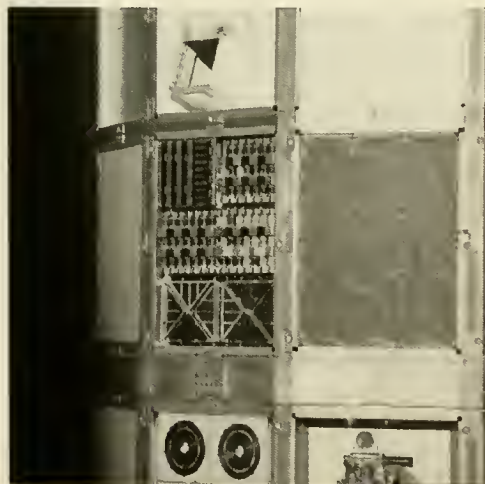
Figure 385
Photo No.: S32-89-052
Dup. Neg. No.: L90-10502
LISAR No.: EL-1994-00137
Photo Credit: JSC
Photo Date: 1/12/90
Location: In Flight
Subject: In-Flight Survey of Tray D12

Figure 385 (In Flight). All experiment test specimens and hardware appear intact. Reflected sunlight caused uneven lighting of the frames of experiment AO023 and a white shape on the tray sidewall above the experiment detector stack. There is some change in the colors of the material of experiment AO180. Note the change in color of the tray clamp white dots across the photograph. The change from white to brown indicates the transition between leading and trailing sides.

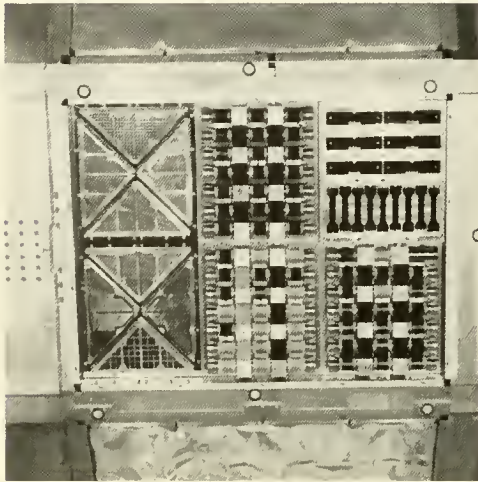
Figure 386 (Postflight). All experiment hardware remains intact. No change from inflight appearance is apparent. There are light reflections on many sensor surfaces.

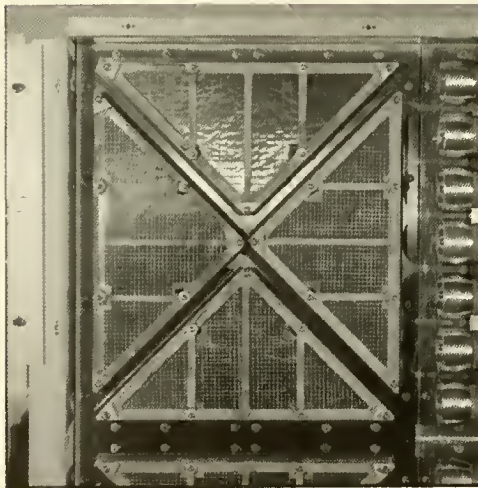
Figure 387 (Postflight). This photograph is of the upper left one-sixth of the tray. The sensor foils in the triangular quadrants are intact and some light reflects on the foil surfaces. There is some discoloration on the mounting frames.

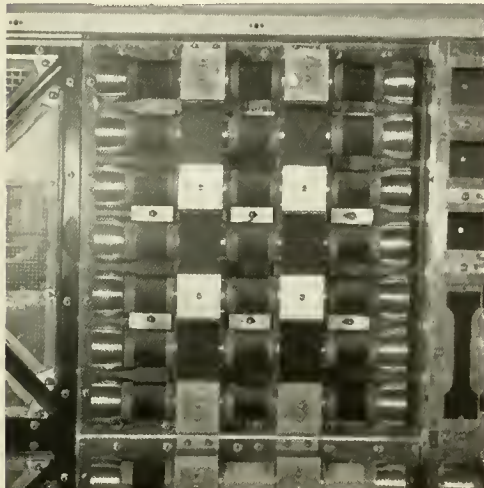
Figure 388
Photo No.: KSC-390C-2035.04
Dup. Neg. No.: L91-10380
LISAR No.: EL-1994-00457
Photo Credit: KSC
Photo Date: 3/16/90
Location: KSC SAEF II
Subject: Postflight Detail of Upper Center of
Tray D12

Figure 388 (Postflight). This photograph is of the upper center one-sixth of the tray. There is little change in the colors of the test specimens.

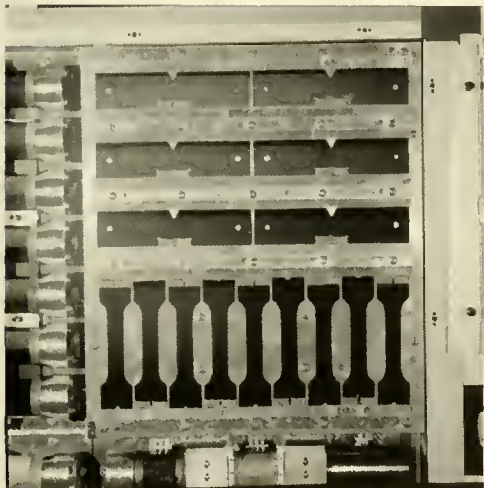
Figure 389
Photo No.: KSC-390C-2035.05
Dup. Neg. No.: L91-10381
LISAR No.: EL-1994-00458
Photo Credit: KSC
Photo Date: 3/16/90
Location: KSC SAEF II
Subject: Postflight Detail of Upper Right of
Tray D12

Figure 389 (Postflight). This photograph is of the upper right one-sixth of the tray. The test specimens are intact with no visible difference from preflight. The red passive temperature indicators remain bonded to the test specimens.

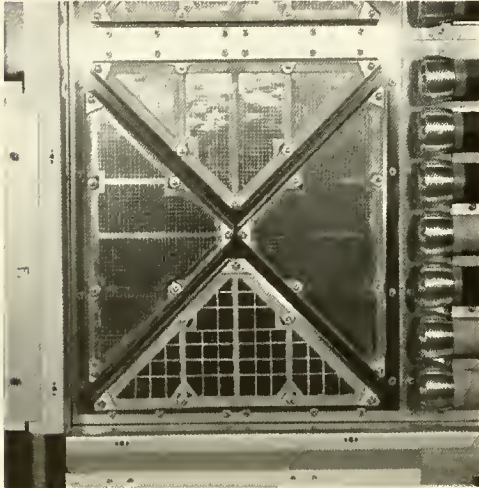
Figure 390 (Postflight). This photograph is of the lower left one-sixth of the tray. The sensor foils in the triangular quadrants are intact and some light reflects on the foils of the upper section. There is some discolorations along the foil and mounting frame line of the left and right quadrants.

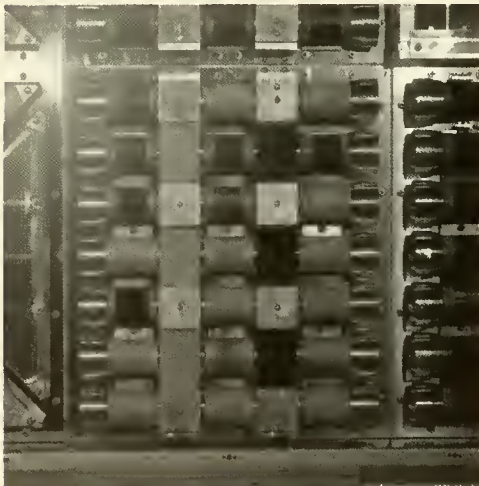
Figure 391 (Postflight). This photograph is of the lower center one-sixth of the tray. The test specimens are intact, but some are darker than in the preflight photograph.

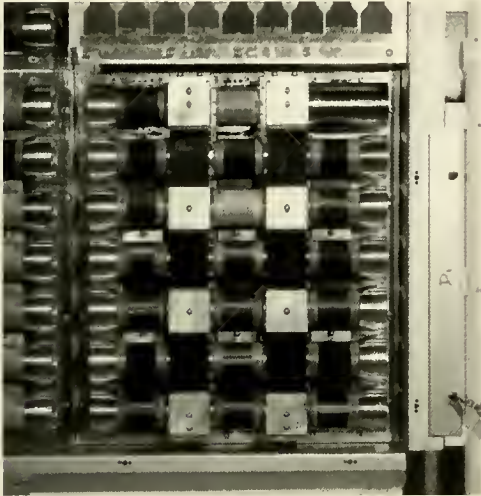
Figure 392 (Postflight). This photograph is of the lower right one-sixth of the tray. The test specimens are intact, but some are darker than in the preflight photograph.

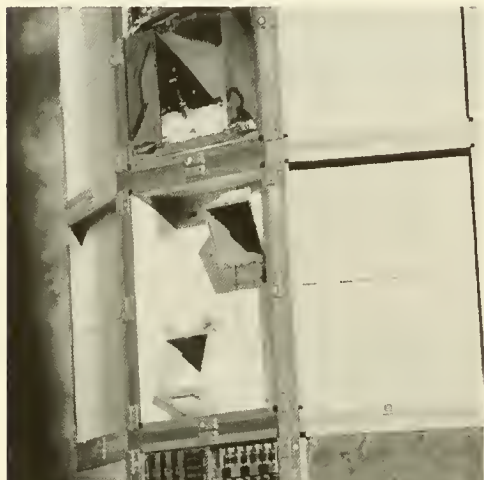
Figure 393 (In Flight). The pink and greenish-gray tints on the two debris panels are by-products of the chromic anodize coating process and are not attributed to contamination or exposure to the space environment. The light color band across the top of the panels is a reflection from the tray sidewall.

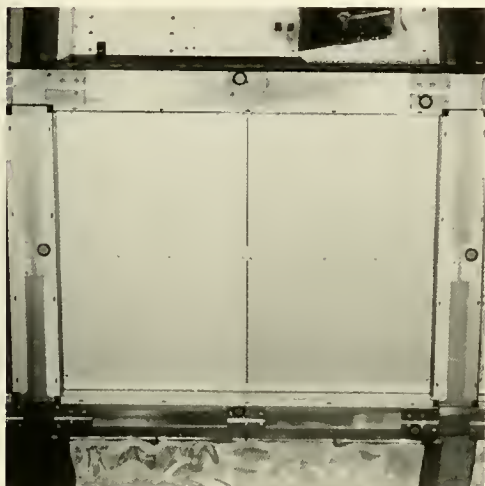
Figure 394
Photo No.: KSC-390C-1066.08
Dup. Neg. No.: L90-13477
LISAR No.: EL-1994-00187
Photo Credit: KSC
Photo Date: 2/8/90
Location: KSC SAEF II
Subject: Postflight Survey of Tray E1

Figure 394 (Postflight). The pink and greenish-gray tints on the two debris panels are by-products of the chromic anodize coating process and are not attributed to contamination or exposure to the space environment. The light band along the bottom of the panels is caused by light reflecting from the tray sidewalls.

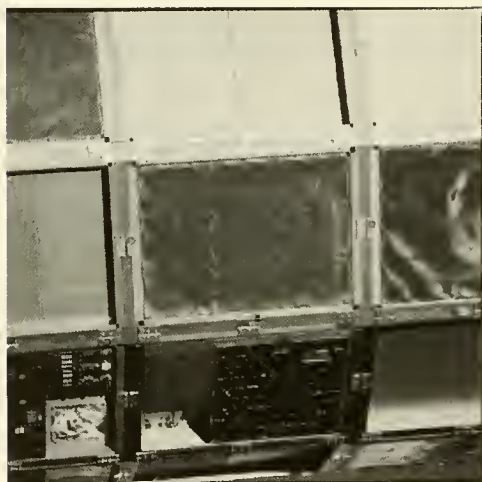
Figure 395 (In Flight). The thermal cover appears to be without visible damage, but it is more taut than in the prelaunch photograph. The Velcro attachment pads are evident. The grainy pattern in the surface finish, which is visible in the light reflection, was on the material prior to flight and is not from the space environment. The rippled effect around the cover edges occurs between the attachment pads.

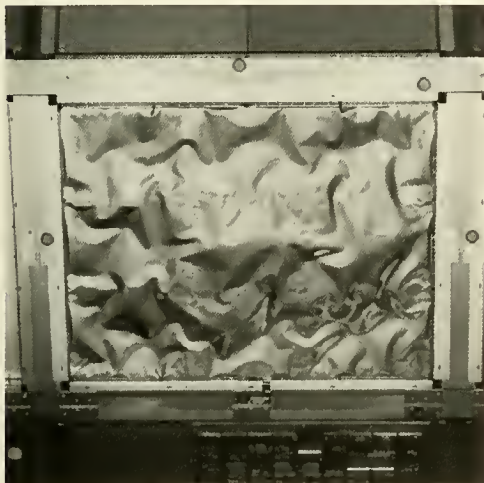
Figure 396
Photo No.: KSC-390C-1065.11
Dup. Neg.: L90-13468
LISAR No.: EL-1994-00385
Photo Credit: KSC
Photo Date: 2/8/90
Location: KSC SAEF II
Subject: Postflight Survey of Tray E2

Figure 396 (Postflight). The thermal cover appears to be specular with no apparent damage. It is less taut than in the in-flight photograph. The Velcro attachment pads are more visible than in the prelaunch photograph. The scallop effect around the cover edges occurs between the attachment pads and shows the upper edge of the support frame. The ground strap is in place with no visible damage, but it is a darker color.

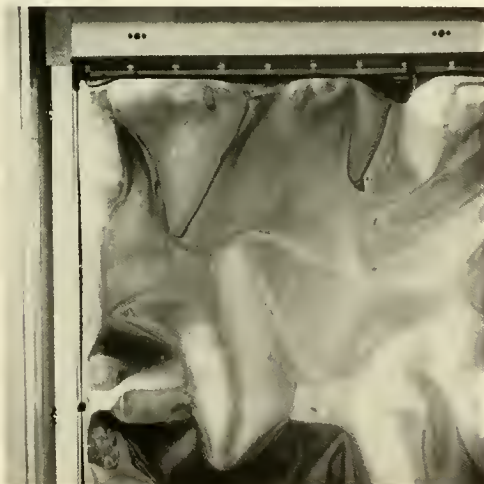
Figure 397
Photo No.: KSC-390C-2336.03
Dup. Neg. No.: L91-10423
LISAR No.: EL-1994-006026
Photo Credit: KSC
Photo Date: 3/27/90
Location: KSC SAEF II
Subject: Postflight Detail of Upper Left of Tray E2

Figure 397 (Postflight). This photograph is of the upper left one-sixth of the tray. The thermal cover appears specular with no apparent damage. The reflective properties of the uneven surface of the cover result in various light and color patterns. The locations of the Velcro attachment pads are visible.

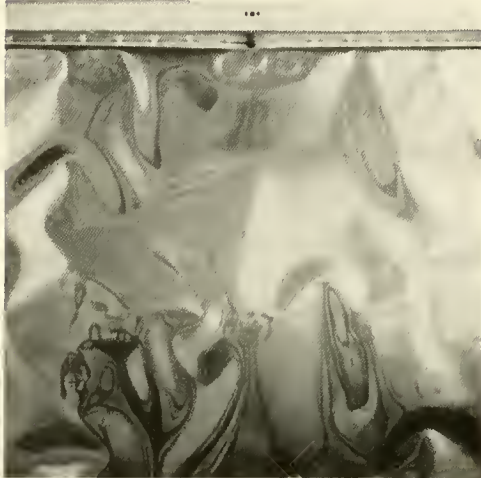
Figure 398 (Postflight). This photograph is of the upper center one-sixth of the tray. The thermal cover appears specular with no apparent damage. The reflective properties of the uneven surface of the cover result in various light and color patterns. The locations of the Velcro attachment pads are visible.

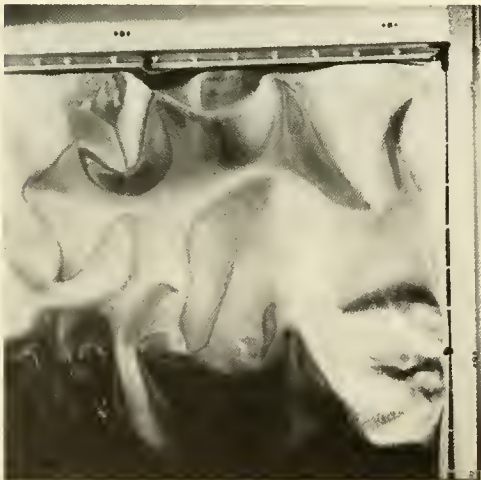
Figure 399 (Postflight). This photograph is of the upper right one-sixth of the tray. The grainy pattern in the surface finish, which is visible in the light reflection, was on the material prior to flight. The thermal cover appears specular with no apparent damage. The reflective properties of the uneven surface of the cover result in various light and color patterns. The locations of the Velcro attachment pads are visible.

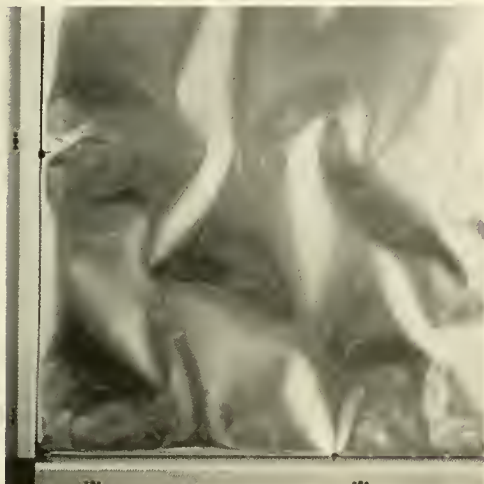
Figure 400
Photo No.: KSC-390C-2336.09
Dup. Neg. No.: L91-10429
LISAR No.: EL-1994-00605
Photo Credit: KSC
Photo Date: 3/27/90
Location: KSC SAEF II
Subject: Postflight Detail of Lower Left of Tray E2

Figure 400 (Postflight). This photograph is of the lower left one-sixth of the tray. The thermal cover appears specular with no apparent damage. The reflective properties of the uneven surface of the cover result in various light and color patterns. The locations of the Velcro attachment pads are visible.

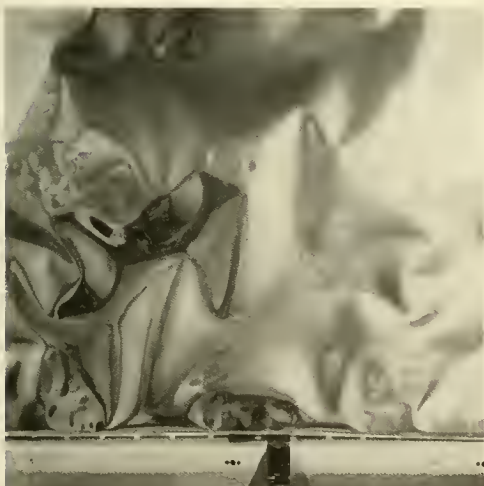
Figure 401
Photo No.: KSC-390C-2336.10
Dup. Neg. No.: L91-10430
LISAR No.: EL-1994-00617
Photo Credit: KSC
Photo Date: 3/27/90
Location: KSC SAEF II
Subject: Postflight Detail of Lower Center of
Tray E2

Figure 401 (Postflight). This photograph is of the lower center one-sixth of the tray. The thermal cover appears specular with no apparent damage. The reflective properties of the uneven surface of the cover result in various light and color patterns. The locations of the Velcro attachment pads are visible.

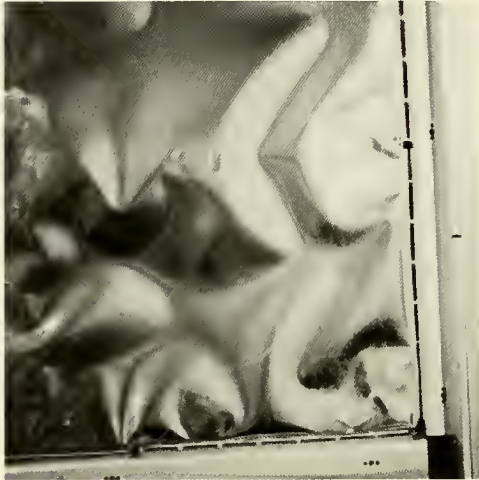
Figure 402 (Postflight). This photograph is of the lower right one-sixth of the tray. The grainy pattern in the surface finish, which is visible in the light reflection, was on the material prior to flight. The thermal cover appears specular with no apparent damage. The reflective properties of the uneven surface of the cover result in various light and color patterns. The locations of the Velcro attachment pads are visible.

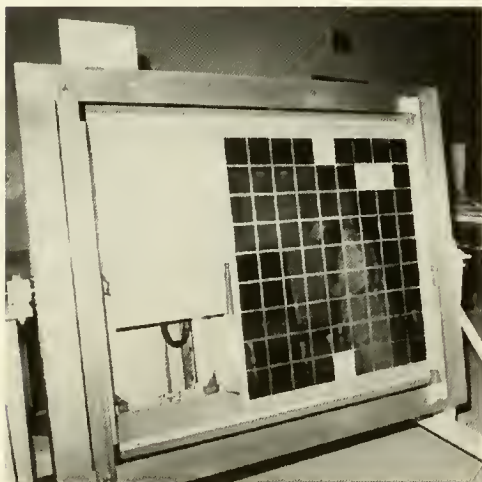
Figure 403
Photo No.: KSC-383C-4209.06
Dup. Neg. No.: L84-7293
LISAR No.: EL-1994-00301
Photo Credit: KSC
Photo Date: 12/1/83
Location: KSC SAEF II
Subject: Preflight Survey of Tray E3

Figure 403 (Preflight). This photograph shows experiment AO187-2 in the right two-thirds of the tray and the EECC that contained experiment S1002 in the left one-third. The tan strips on the tray flanges are protective coatings that were removed prior to tray testing. Each of the 77 capture cells of experiment AO187-2 consisted of four highly polished germanium plates. These plates were covered with a 2.5- μ m thick Mylar foil with 1300 A of tantalum vapor that was deposited on the back and 100 A of gold-palladium that was vapor deposited on the front. Two calorimeters are shown mounted in the top center and lower center of the experiment panel. An aluminum cover in the upper right section of the panel protected electrical connections. Reflections of both personnel and equipment are visible in the metallic-coated Mylar foil that covers the germanium detector plates.

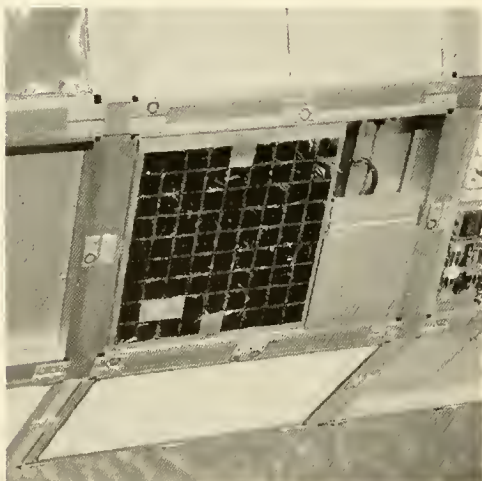
Figure 404
Photo No.: S32-77-067
Dup. Neg. No.: L90-10417
LISAR No.: EL-1994-00001
Photo Credit: JSC
Photo Date: 1/12/90
Location: KSC SAEF II
Subject: In-Flight Survey of Tray E3

Figure 404 (In Flight). The capture cells appear to be severely damaged. Fragments of the failed capture cell covers, which have curled into tight conical shapes, are attached to edges of the aluminum mounting frame. The capture cell mounting structure and calorimeter mounting plates are discolored; some areas have more pronounced discoloration than others. The canister for experiment S1002 is closed.
